Attachment 4
Photograph Log

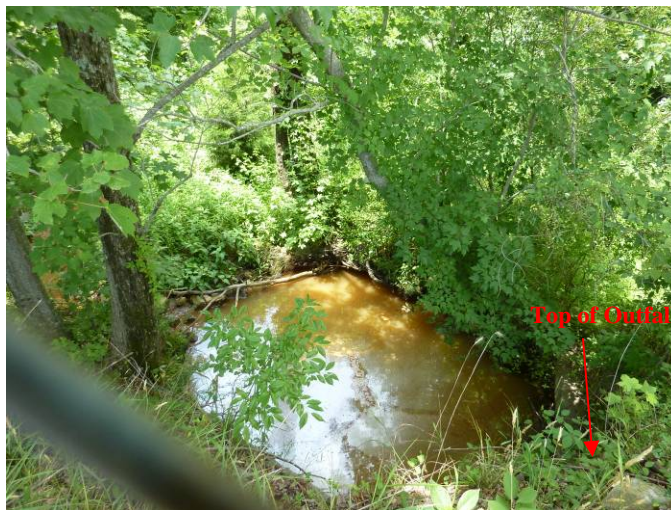
Photograph 77. Municipal Yard Outfall – View of orange-brown water and oily sheen near outfall

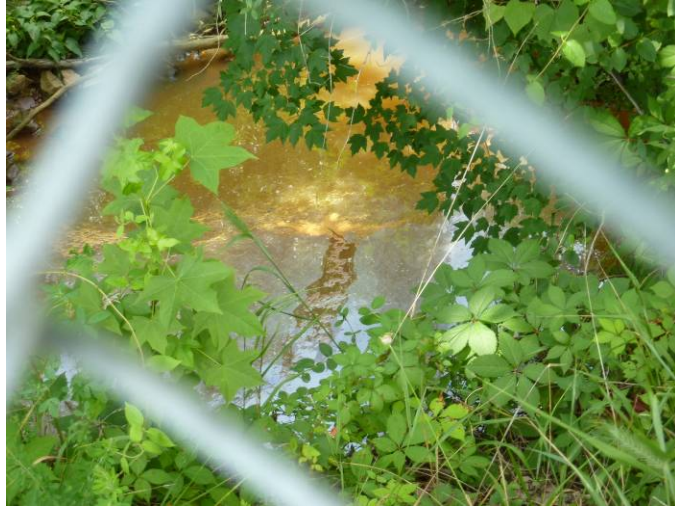
Photograph 78. Municipal Yard Outfall – View of orange-brown water, orange froth and oily sheen near outfall

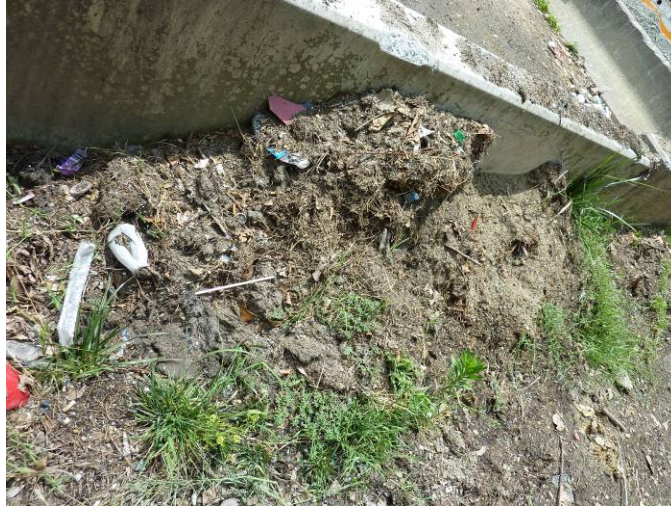
Photograph 82. City Stockpile Area – Trash piled behind barricades

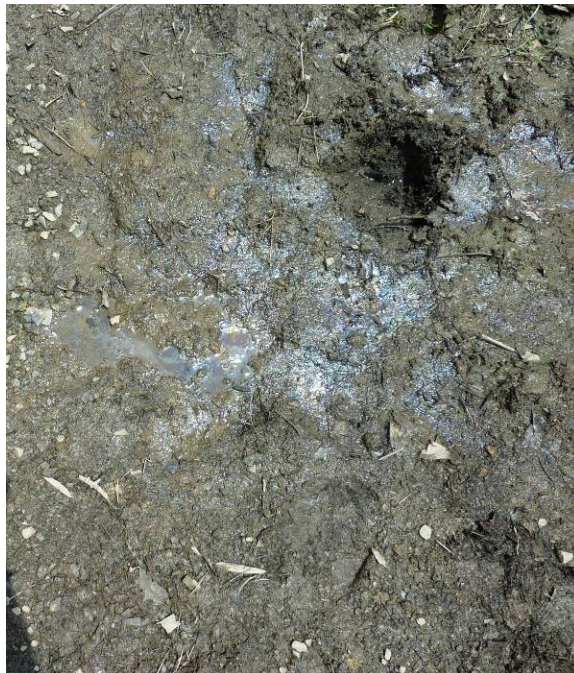
Photograph 83. City Stockpile Area – Oily sheen on mud behind barricades
